POTENTIAL FAILURE MODE ANALYSIS
KOOTENAI DEVELOPMENT IMPOUNDMENT DAM

LINCOLN COUNTY, MONTANA

August 23, 2011

Billmayer & Hafferman, Inc.
Kalispell, MT

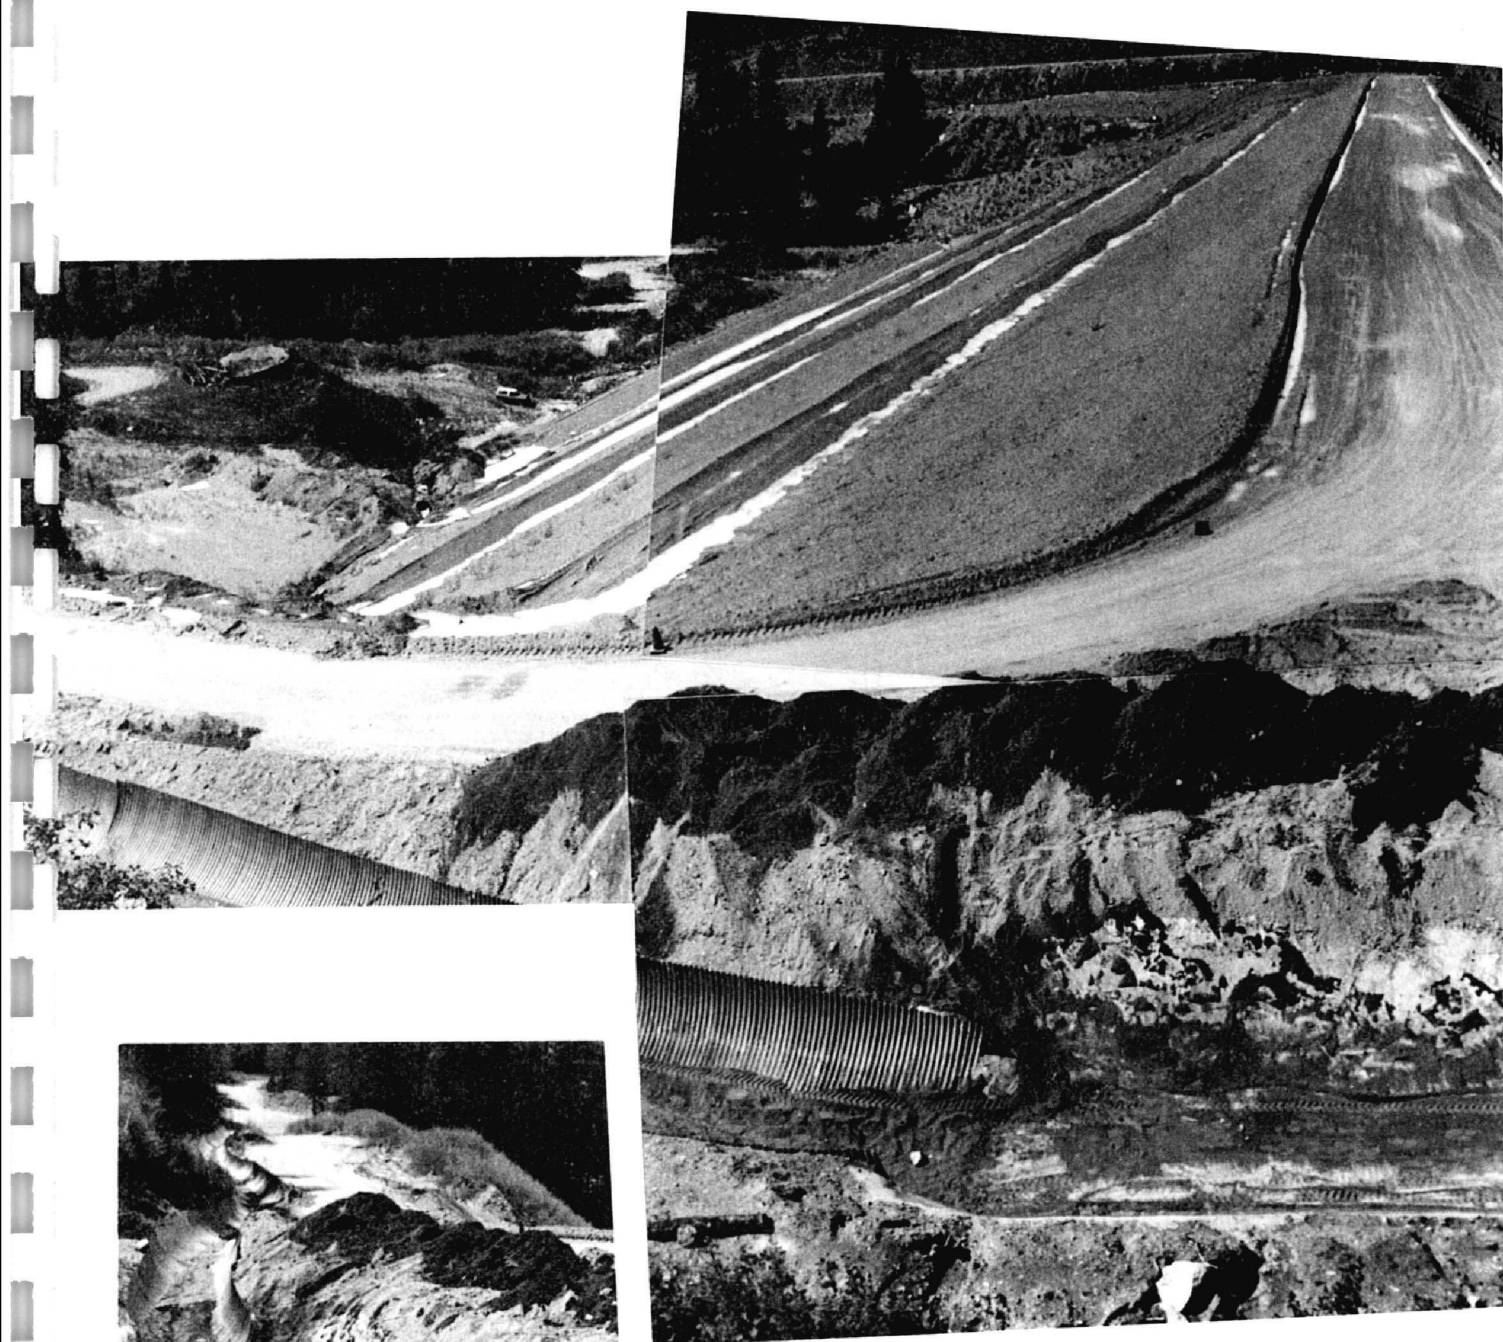
Photo 6 Zonolite Spillway and Downstream Face (8-13-81)

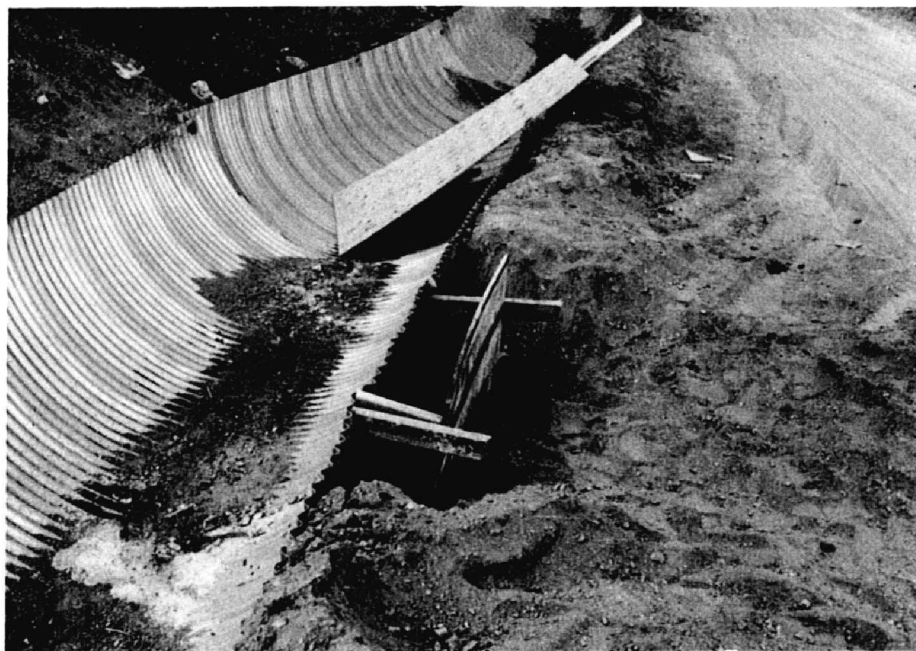
Photo 10 Spillway Foundation Collar (8-13-81)

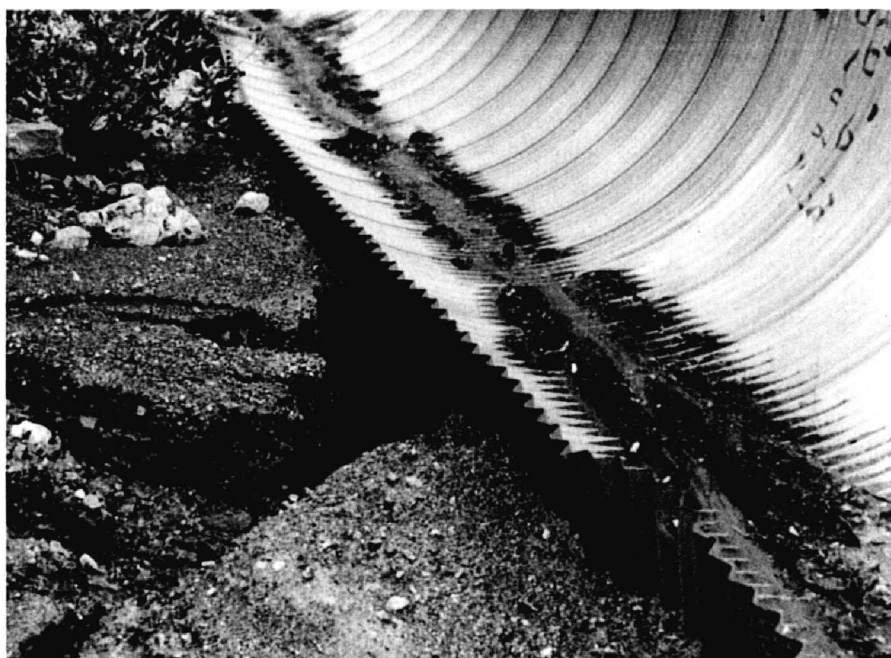
Photo 11 Erosion of Backfill and Undermining of Spillway Chute (7-81)

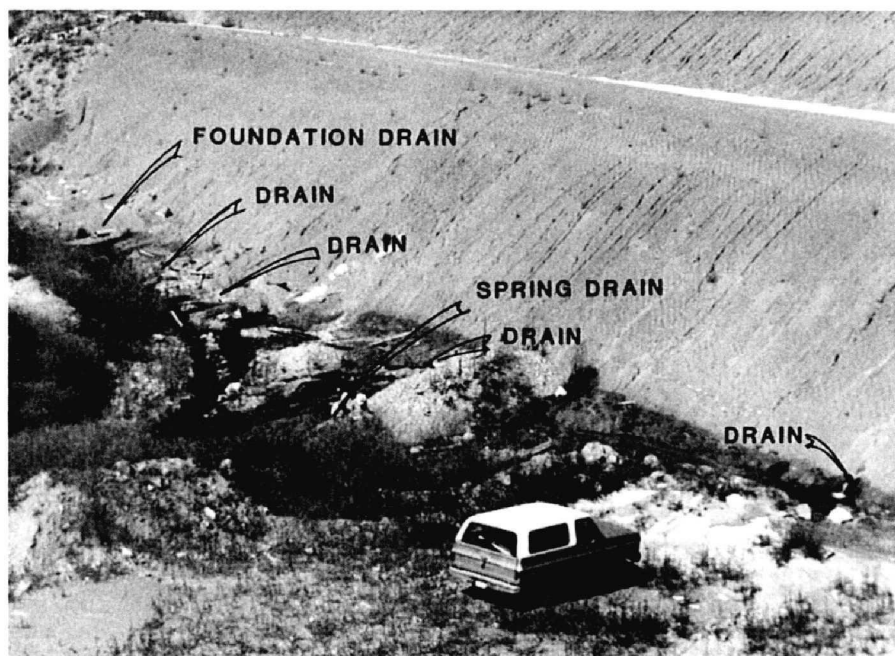
Photo 19 Foundation and Spring Drains. Note
Wetted Front (8-13-81)

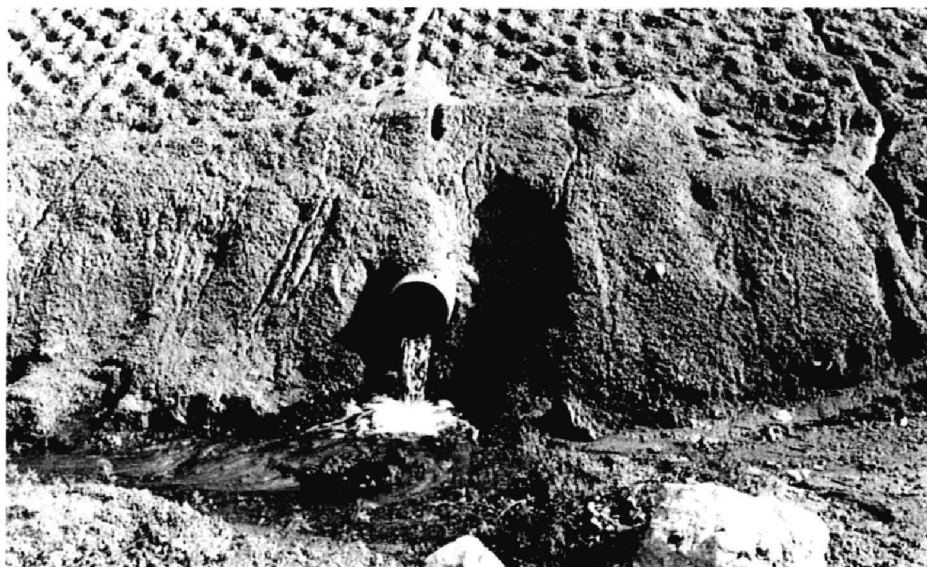
Photo 20 First Exposed Drain Closest to East (left) Abutment (8-13-81)

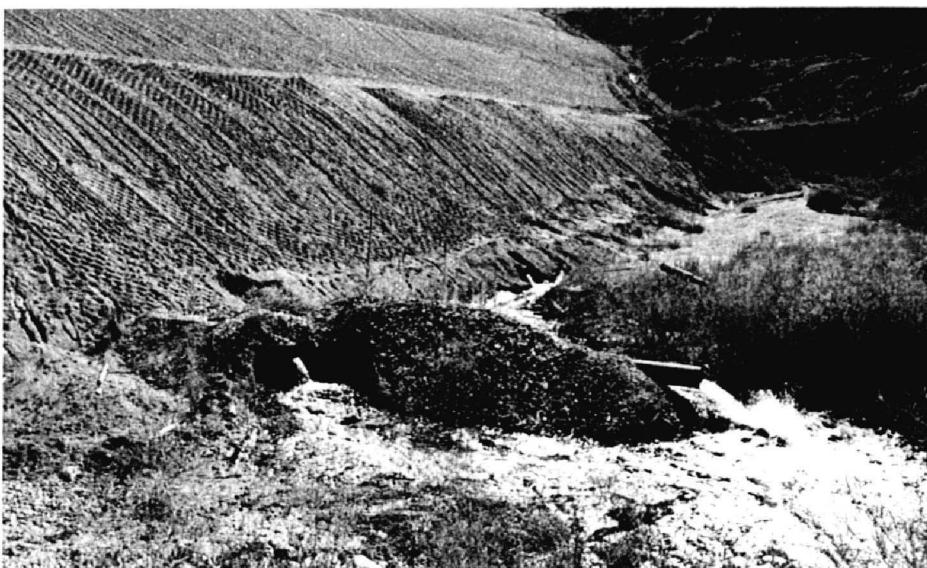
Photo 22 Foundation and Spring Drains Looking Towards the East (8-13-81)

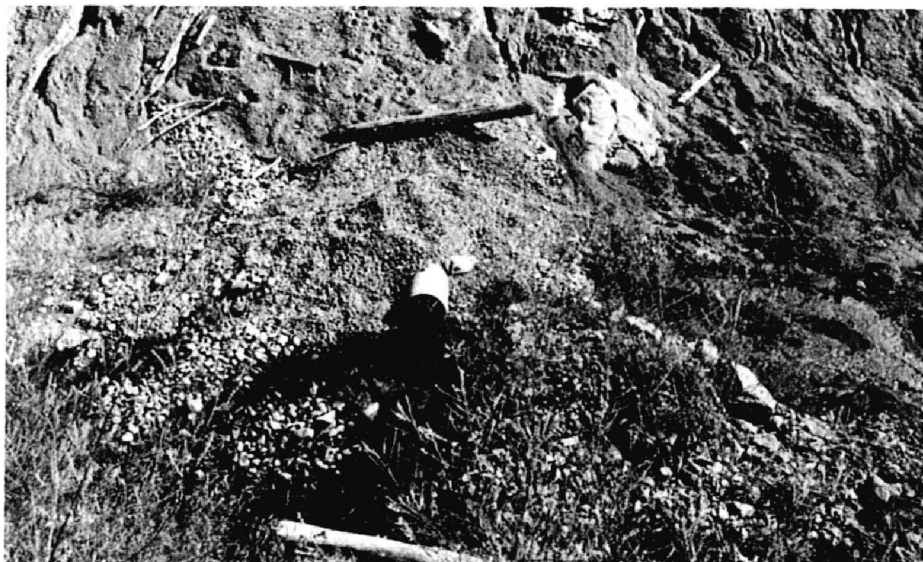
Photo 23 Third Exposed Foundation Drain from East Abutment (8-13-81)

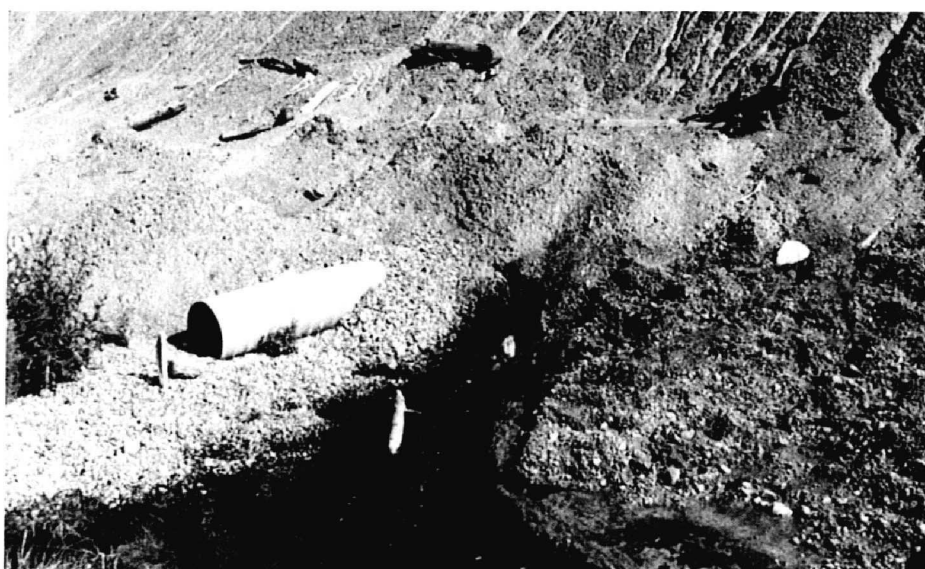
Photo 24 Fourth Exposed Foundation Drain from East Abutment (8-13-81)

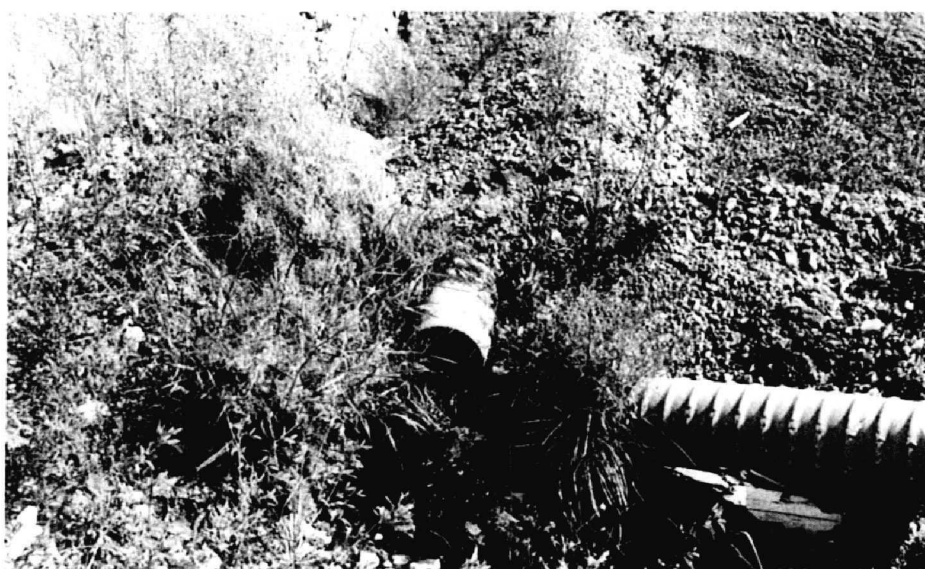
Photo 25 Fifth Exposed Foundation Drain from East Abutment (8-13-81)
